Manhole Inspection Summary

Manhole # S37GG1024MH

Location Address: **4005 OLD YORK RD**

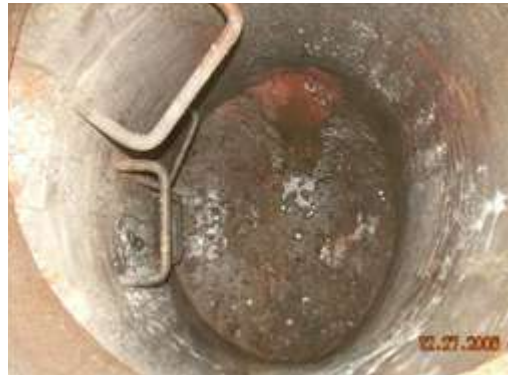
Top View

Corroded steps. Channel debris.

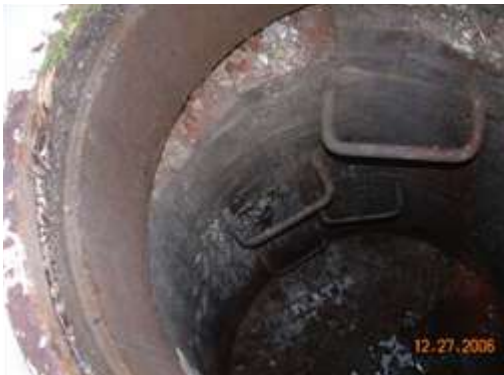
Defect

☒ **Leaks**

Condition: ☐ Sound ☐ Cracked ☐ Root Intrusion ☒ **Loose Brick** ☒ **Deteriorated**

Infiltration: ☐ None ☒ **Joint** ☐ Cracks ☐ Mortar ☐ Roots ☒ **Wall**

Infiltration: ☐ None ☐ Joint ☐ Cracks ☐ Mortar ☐ Roots ☒ **Wall**

Frame leaks. Adjustment deterioration, loose brick and infiltration. Barrel infiltration.

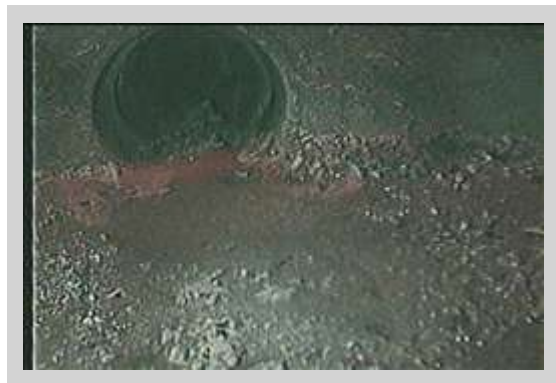
Pipe Out @ 12 O'Clock

8 in. Circular Gravity Sewer

Deposits: ☐ None ☒ **Mud** ☐ Sludge ☒ **Debris** ☐ Grease

Silt Depth: **1** (in.)

Deposits Extent: **Light**
